Intel[®] StrongARM[®] SA-1100 Microprocessor

Specification Update

February 2000

Order Number: [278105-025](#)

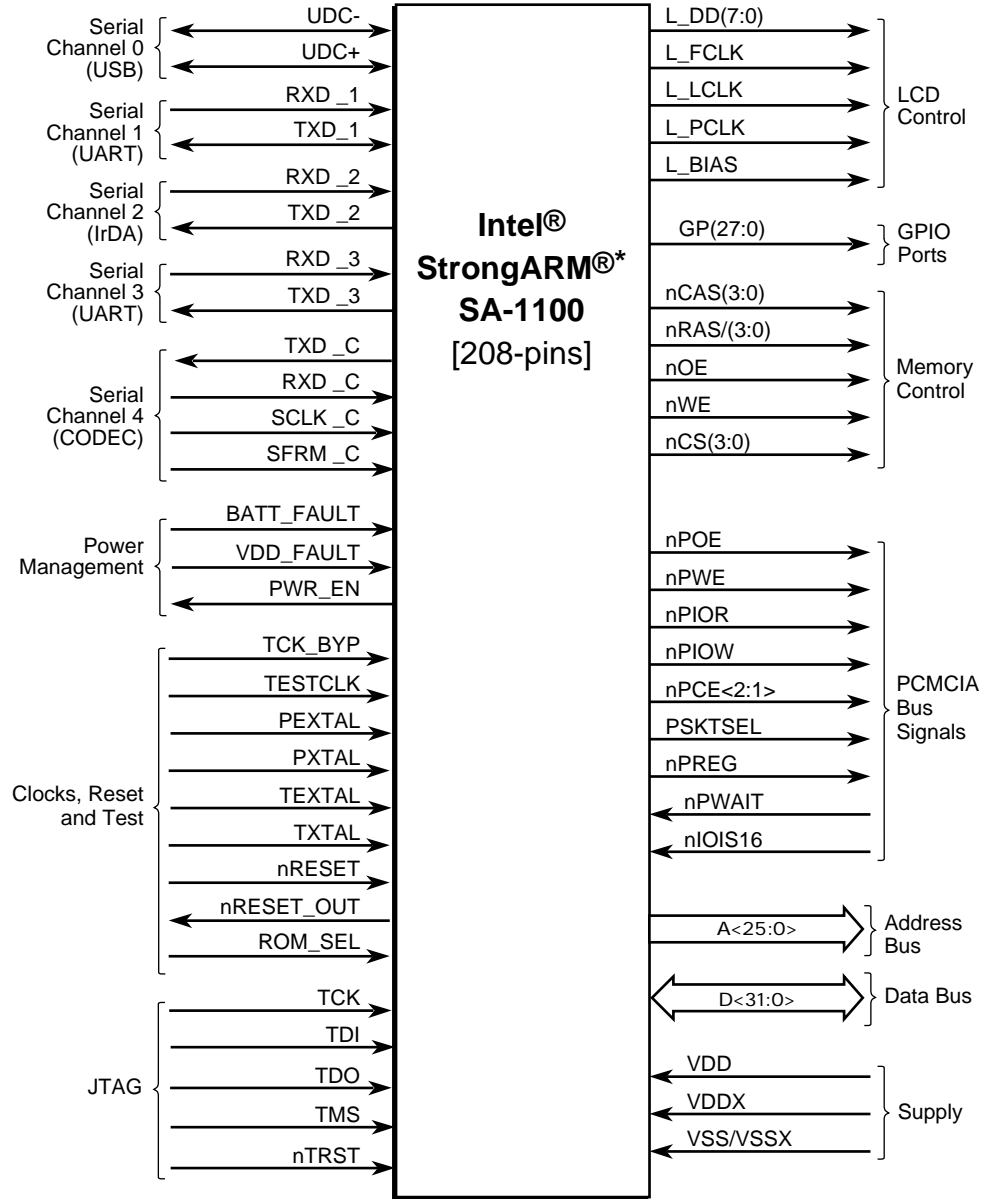
14. SA-1100 Functional Diagram: Figure 2-2

Changed label for Serial Channel 1.

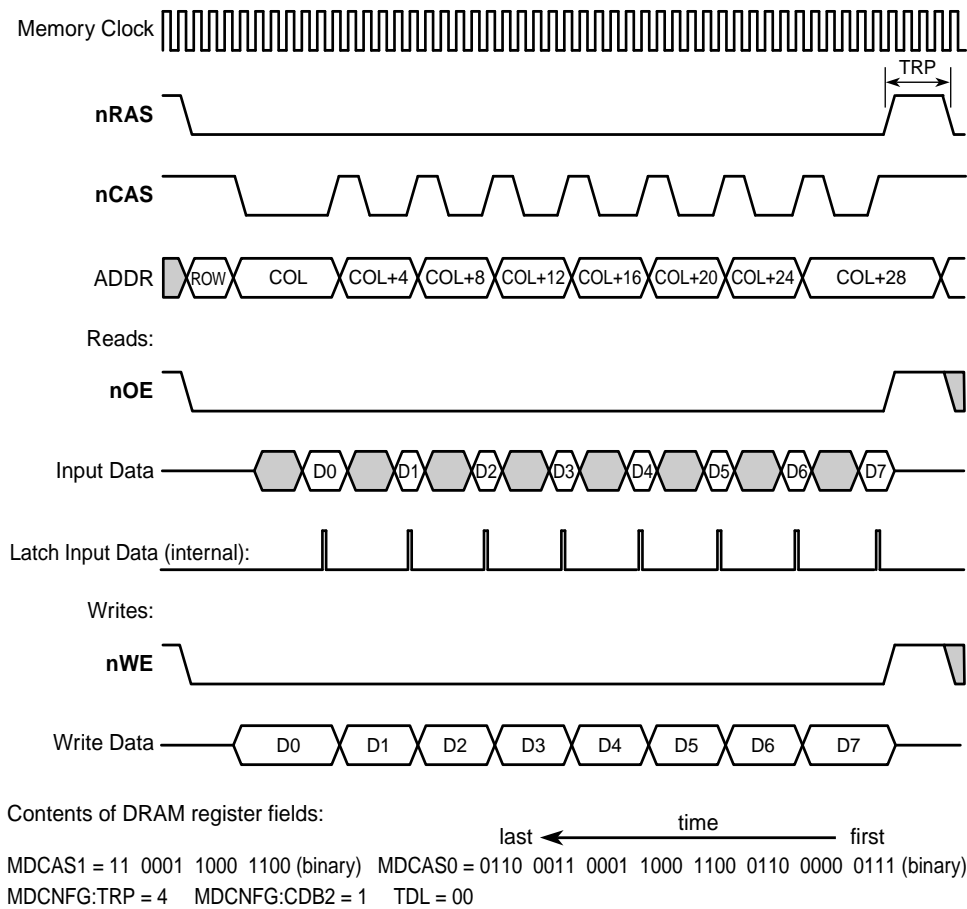
20. DRAM Timing: Section 10.3.2

Update Figure 10-4 as shown below.

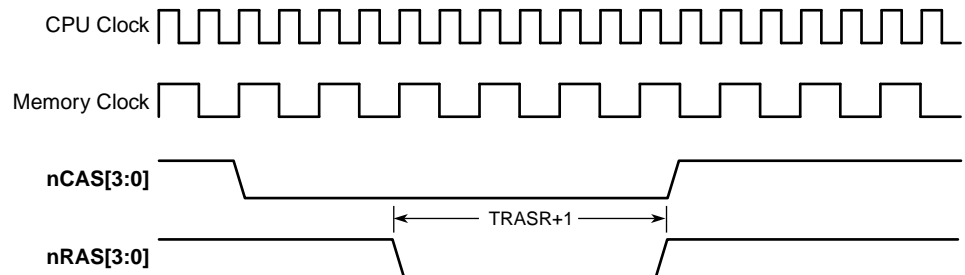
21. DRAM Refresh: Section 10.3.3

Update Figure 10-5 as shown below.

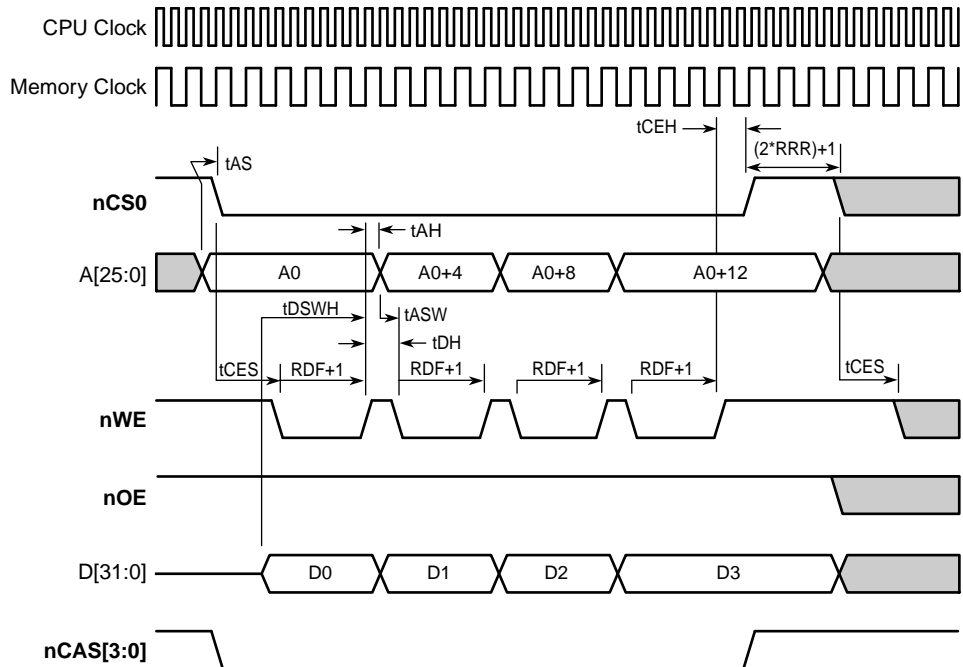
SRAM Timing Diagrams and Parameters: Section 10.4.4

Update Figure 10-9 as shown below.

Changed the “tDSWH = Write data setup to nWE high (deasserted) = 1/2 memory cycle + (RDN+1) memory cycles” line in the parameters list (following the figure) to:

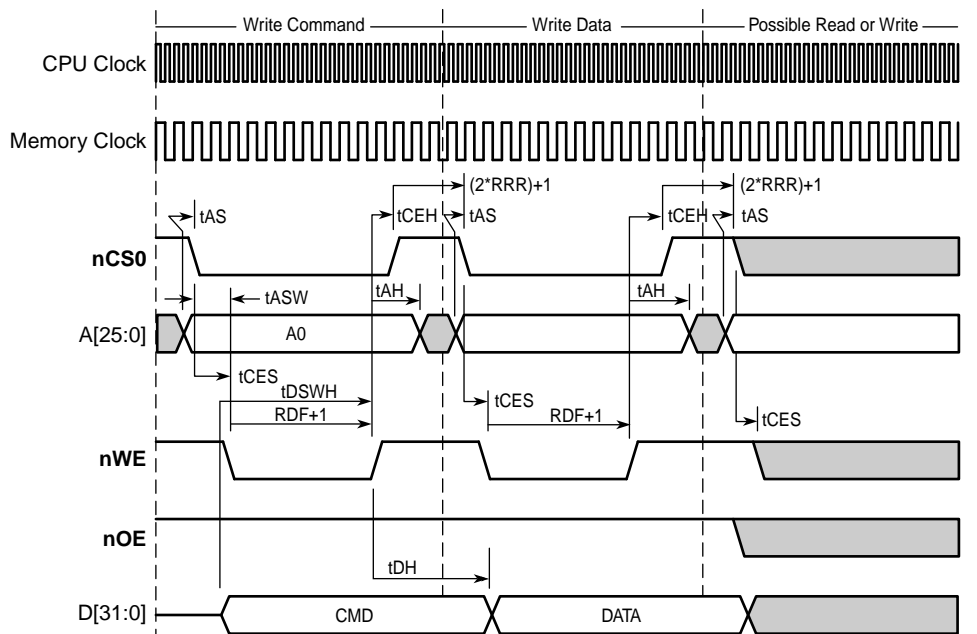
24. FLASH EPROM Timing Diagrams and Parameters: Section 10.4.6

Update Figure 10-10 as shown below.

Changed the “ $t_{DSWH} = \text{Write data setup to nWE high (deasserted)} = 1/2 \text{ memory cycle} + (\text{RDN}+1) \text{ memory cycles}$ ” line in the parameters list (following the figure) to:
