3 VOLT FlashFile™ MEMORY

28F004S3, 28F008S3, 28F016S3

SPECIFICATION UPDATE

Release Date: February, 1999

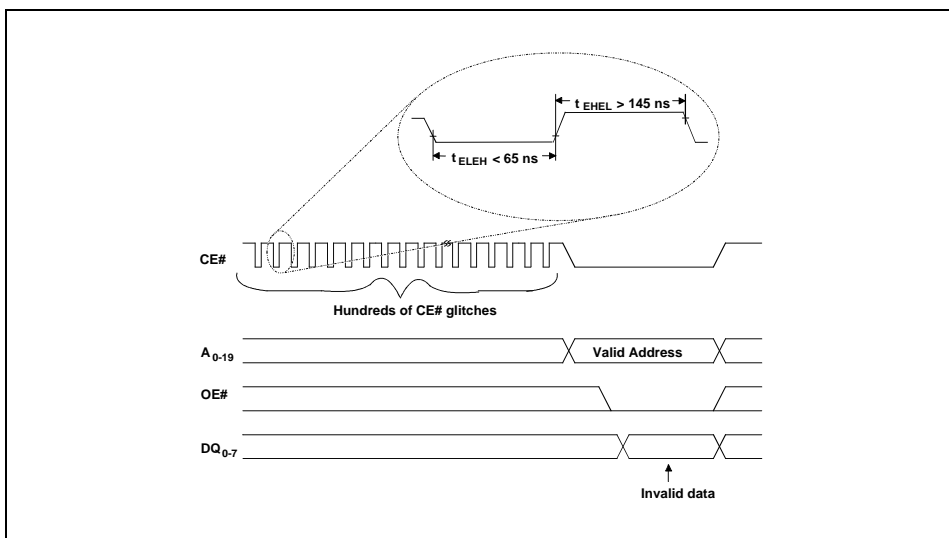
PROBLEM: A noisy CE# control signal may cause an invalid read. This erroneous read only occurs after the device has received over one hundred consecutive short CE# glitches ($t_{EHL} < 65$ ns) with CE#-high time (t_{EHL}) greater than 145 ns (see the figure below, *A Long Series of CE# Glitches May Induce an Invalid Read*).

A Long Series of CE# Glitches May Induce an Invalid Read

After valid data is read, the device must receive another series of CE# glitches (typically over one hundred) to induce an invalid read.

Add system logic to prevent CE# glitches such as latched CE# control logic or pullup/pulldown resistors to the address bus.

If the device receives over one hundred consecutive CE# glitches, issue a Byte Write command and program FFh to any location before executing a read operation. Programming FFh will not alter stored data, but it will give the component sufficient time to prepare for the read operation.
