3 Volt and 5 Volt FlashFile™ Memory

28F160S3, 28F320S3, 28F160S5, 28F320S5 (x8/x16)

Specification Update

Order Number: 297849-011

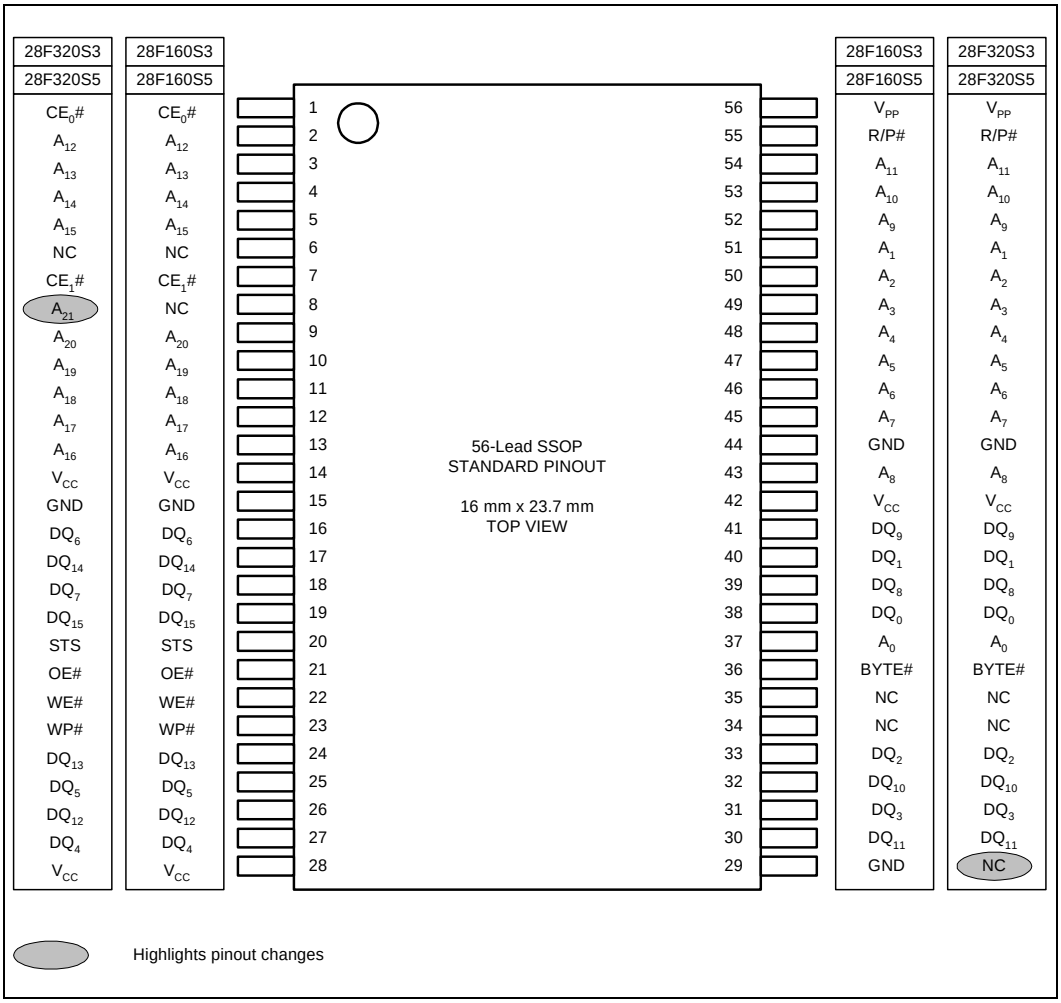
Figure 1. Pin 29 for the 28F320S3/S5 was changed from GND to NC (no connect). NC is defined as: lead is not internally connected; it may be driven or floated.
